2017 Clean Rivers Program Basin Highlights Report

Guadalupe River and Lavaca-Guadalupe Coastal Basins
Featuring the Lower Basin

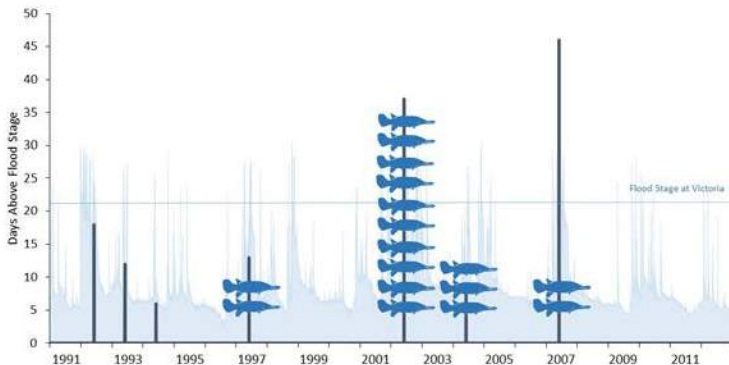
The best years for Alligator Gar reproduction (fish symbols) in the lower Guadalupe River compared to the number of days the river was above flood stage during spring and summer (bars). The background shows river elevation at Victoria for reference.

good reproduction years were 1997, 2004, and 2007. As expected, good reproduction coincided with years where flooding occurred during the spawning season. In fact, the 4 best years for Alligator Gar reproduction since 1991 (when hydrologic data are available) all occurred in years where June and July floods inundated spawning habitats. A detailed model is currently being developed that links floodplain inundation and availability of suitable spawning habitats to improve predictions of reproductive success for Alligator Gar.

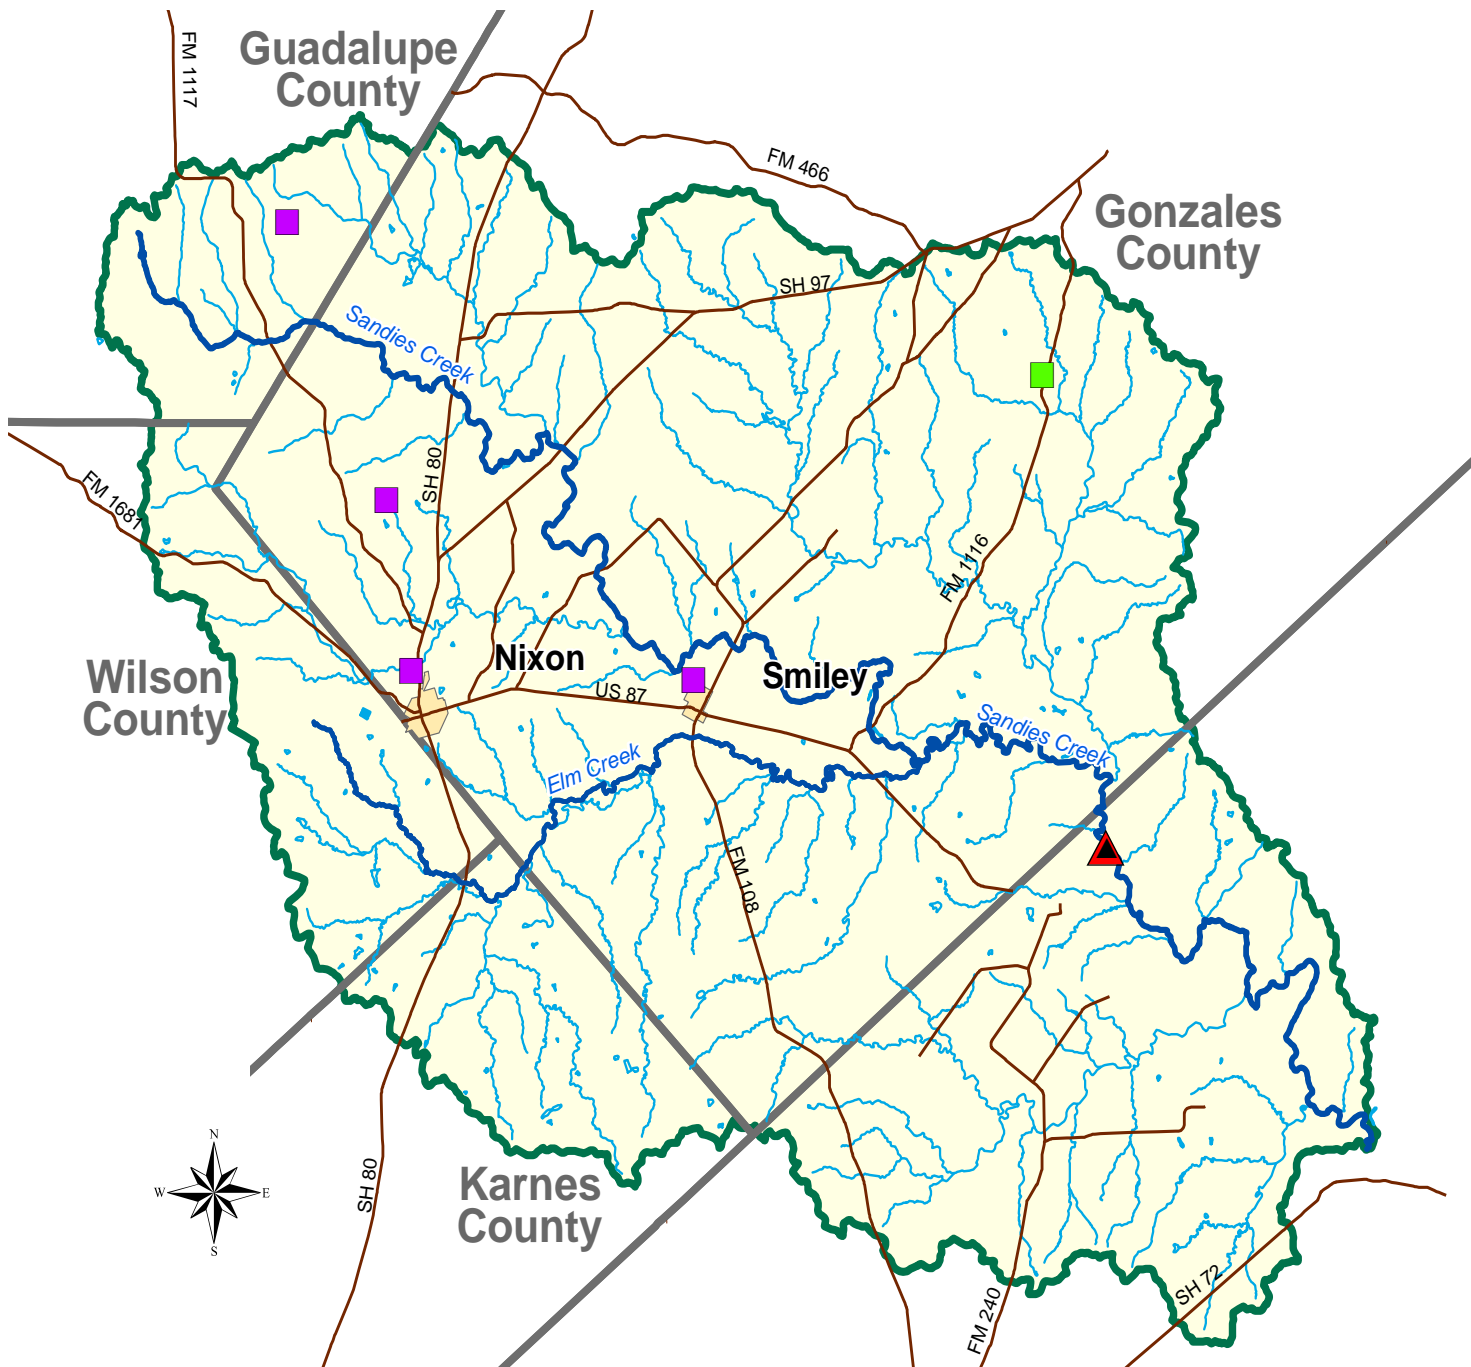
Sandies Creek Watershed

- TCEQ Sampling Site
- GBRA Sampling Site
- USGS Stream Gauge
- Domestic WWTP
- Industrial WWTP
- Watershed
- Counties
- Cities
- Creeks and Rivers
- Streams
- Lakes and Bays
